Manhole Inspection Summary

Manhole # S21CC_049MH

Location Address: **1013 BRUCE ST** Cross Street: **RIGGS-MOSHER**

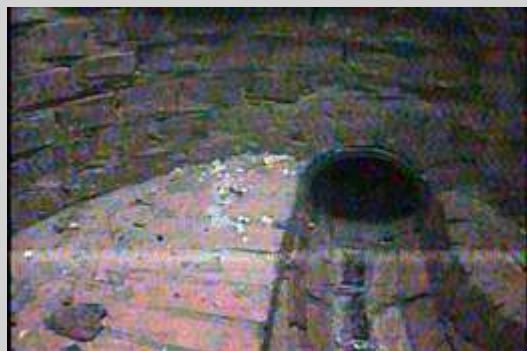
9 O'Clock Inflow

8 in. Circular Gravity Sewer

Pipe In @ 9 O'Clock

Pipe Height: **7.2** (in.) Rod and Bar (Angled)

Pipe Material: **Clay** ☐ Pipe Lined

Infiltration: **None** Pipe Seal Cond: **Sound**
